**PRELIMINARY ASSESSMENT/  
VISUAL SITE INSPECTION**

**MICHIGAN CHROME AND CHEMICAL COMPANY  
DETROIT, MICHIGAN**

**FINAL REPORT**

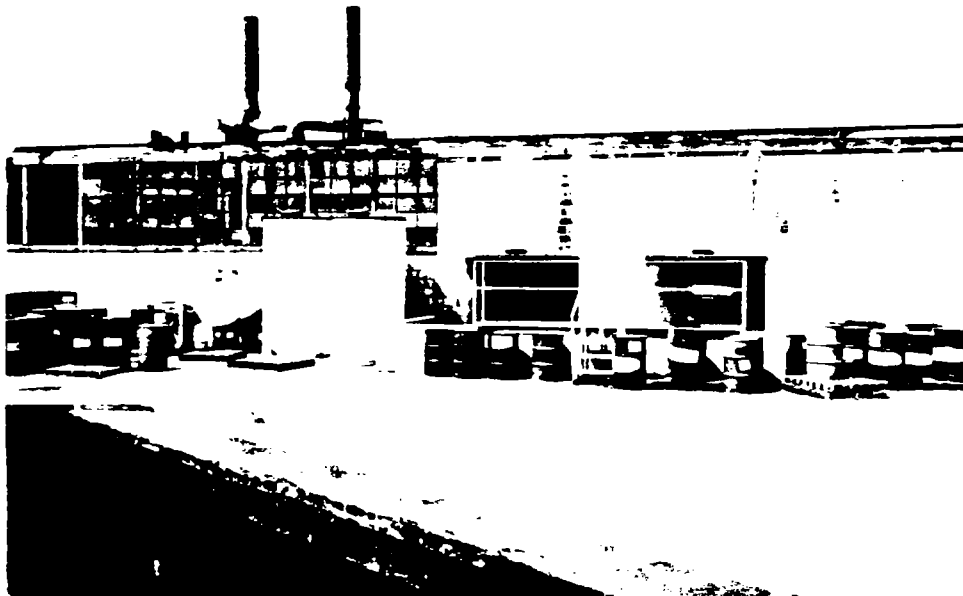
Photo No. 6

Observations: A few small dark stains on the pavement were noticed in the vicinity. However, it is not possible to determine whether the source of the stains is from the drums stored in this area.

Direction Facing: West Name: Michigan Chrome and Chemical Co.  
Date: July 26, 1990 12:35 p.m. EDT SWMU No.: 6  
Description: Drum storage area.
